Manhole Inspection Summary

Manhole # S23II1020MH

Record Plat: **23II1** Node: **020** Status: **Found**

Location Address: **1213 ROLAND HEIGHTS AVE** Cross Street: **NEWPORT AVE**

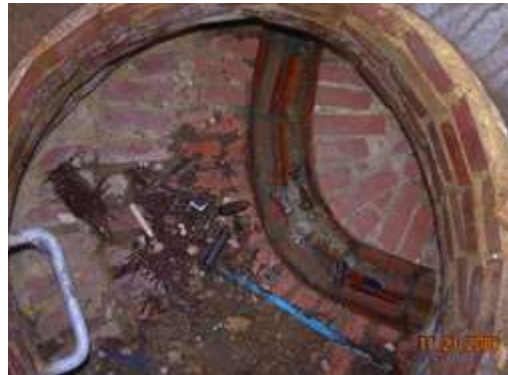
Top View

Bench ☒ Exists Material: **Brick** ☐ Parged ☒ **Debris** (not Condition related)
Condition: ☒ Sound ☐ Cracked ☐ Root Intrusion ☐ Deteriorated ☐ Leaks ☐ Debris

Bench debris.

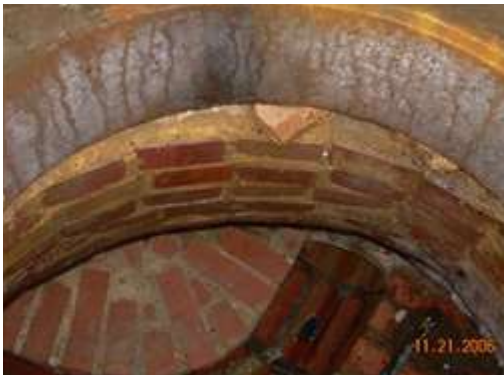
Defect

Chimney / Frame Adjustment ☒ Exists Material: **Brick** ☐ Parged Height: **8** (in.)
Condition: ☐ Sound ☐ Cracked ☐ Root Intrusion ☒ **Loose Brick** ☒ **Deteriorated**
Infiltration: ☐ None ☒ **Joint** ☐ Cracks ☐ Mortar ☐ Roots ☒ **Wall**

Adjustment deterioration, loose brick, and infiltration.

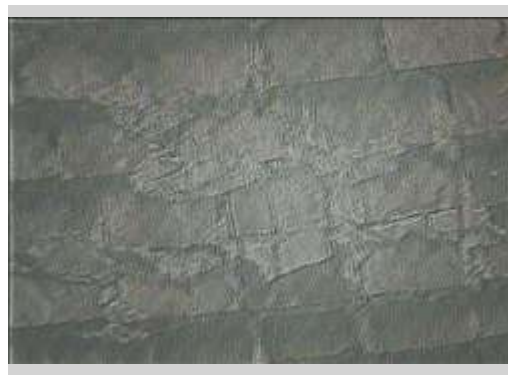
Defect

Barrel Material: **Brick** ☐ Parged
Shape: **Circular** Diameter: **48** (in.) Length: (in.)
Condition: ☐ Sound ☐ Cracked ☐ Root Intrusion ☐ Loose Brick ☒ **Deteriorated**
Infiltration: ☐ None ☐ Joint ☐ Cracks ☒ **Mortar** ☐ Roots ☒ **Wall**

Barrel infiltration.

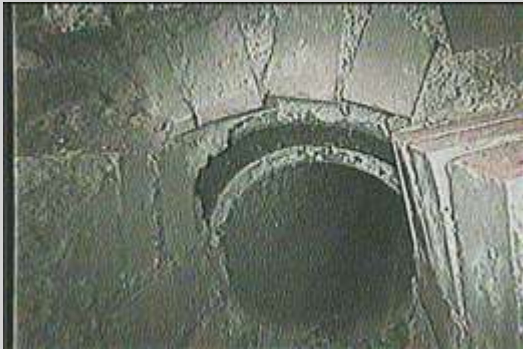
8 in. Circular Gravity Sewer Pipe Out @ 12 O'Clock

Comments **The O12 pipe seal is not flush to the pipe.**

Infiltration: **Evidence** Pipe Seal Cond: **Unknown**

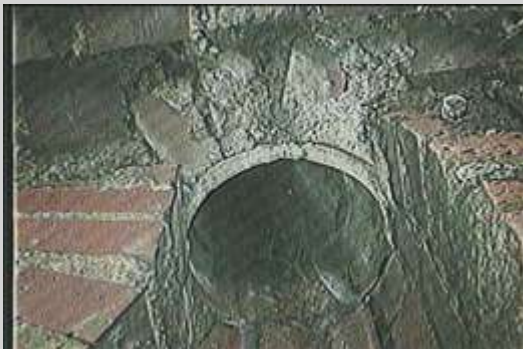
8 in. Circular Gravity Sewer Pipe In @ 3 O'Clock

Barrel deterioration and infiltration.

Infiltration: **None** Pipe Seal Cond: **Cracked**
